**Ally Public Adjusters**

Insured: Robert Bales  
Property: 16207 E 47th Pl  
Tulsa, OK 74134

**Claim Number:** 3629L157B

**Type of Loss:** Hail

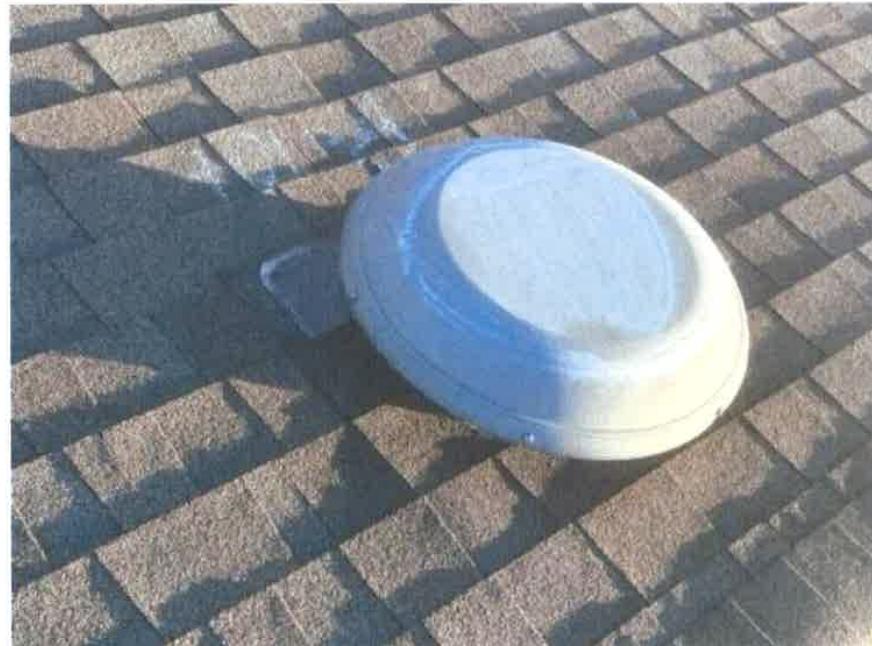
4 3-vent

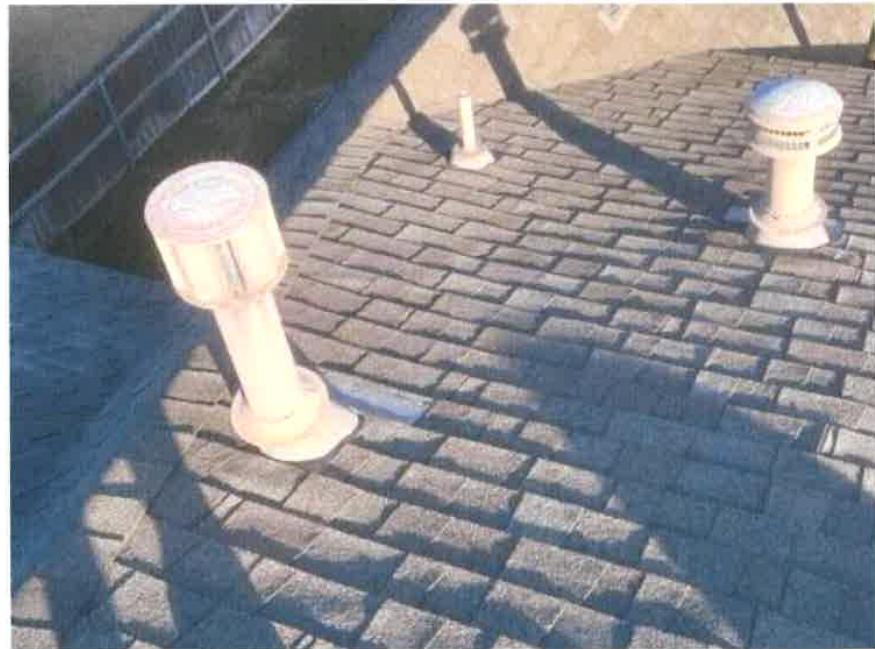
6 5-rain caps  
Date Taken: 1/28/2022

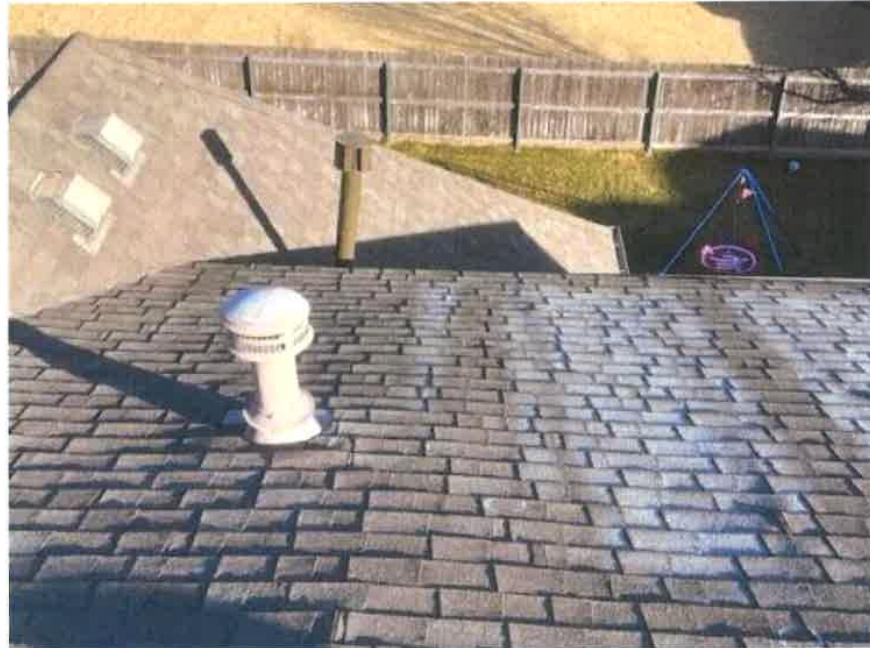
7 6-Rain caps  
Date Taken: 1/28/2022

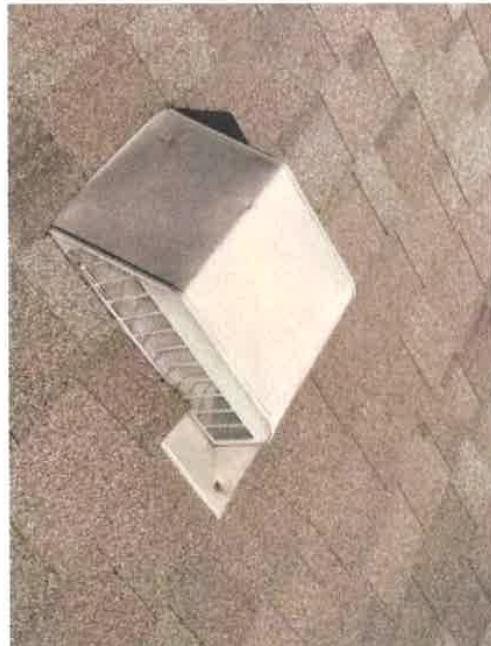
12 11-vents  
Date Taken: 1/28/2022

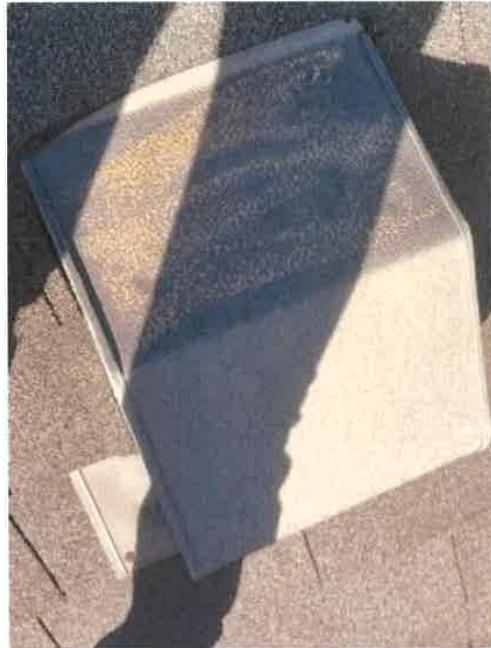
13 12-vents

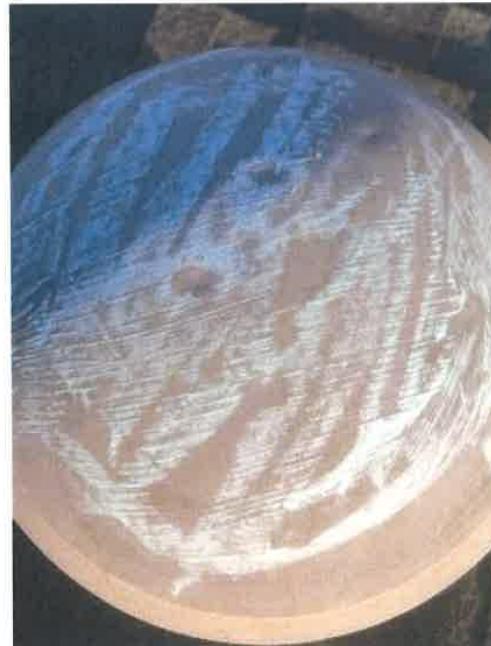
14 13-vent cover

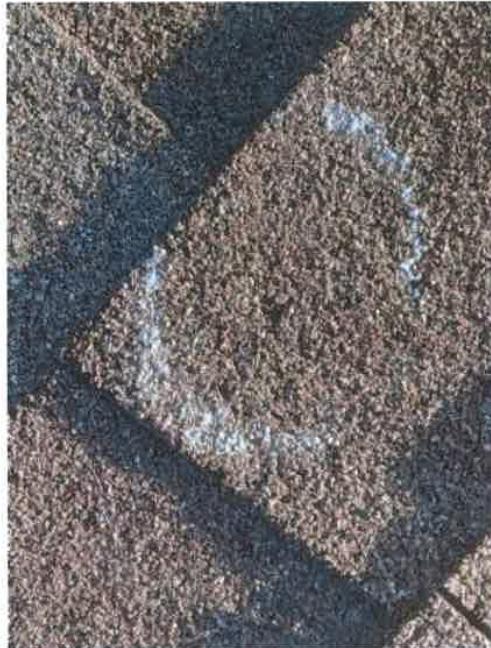
15 14-Hail Hit  
Date Taken: 1/28/2022

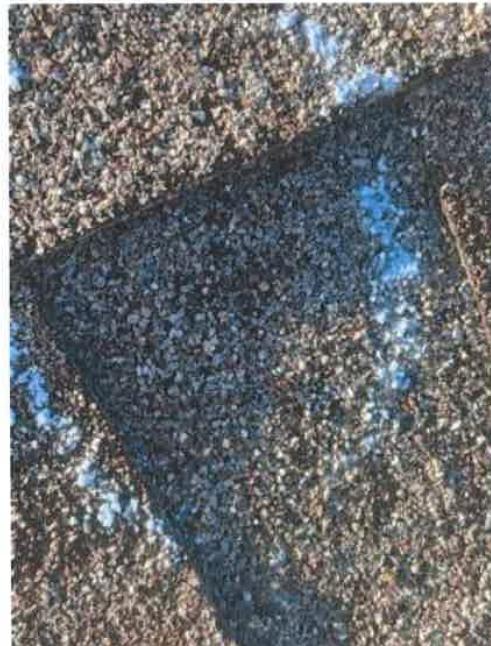
16 15-hail hit  
Date Taken: 1/28/2022

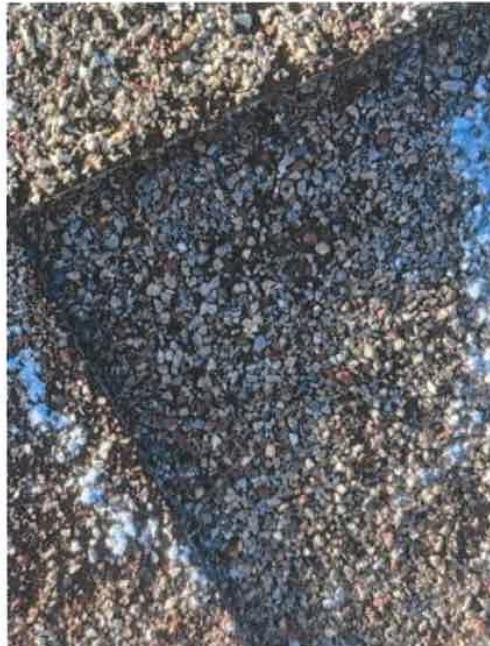
17 16-hail hit

granule loss due to hail impact

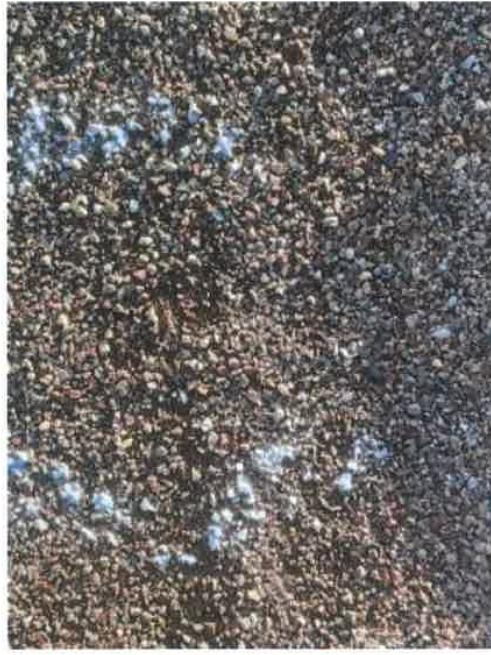
19 18-hail hit

This white chalk mark was made by the SF representative to demonstrate a hail hit.

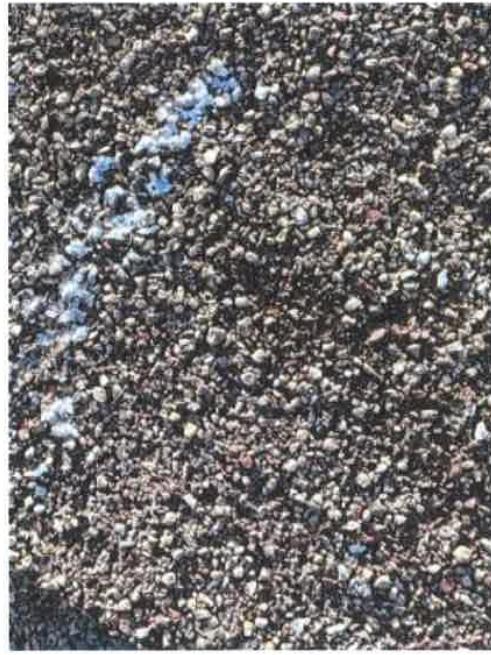
21 20-Hail hit

Another hail hit marked by SF  
representative. THis is a classic  
appearance of hail hits.

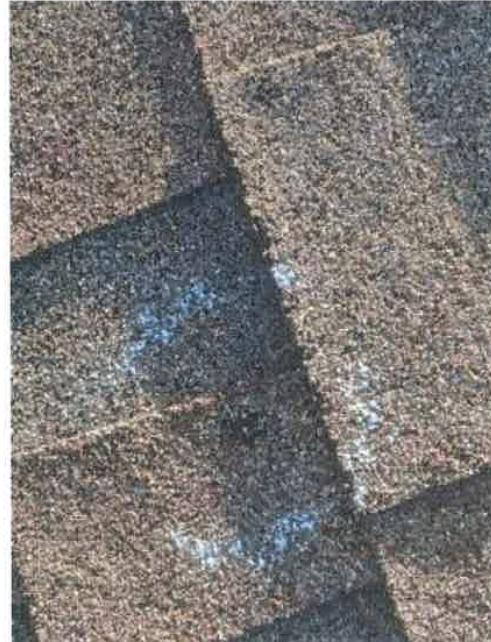
22 21-Hail impact

Another hail hit marked by SF  
representative.

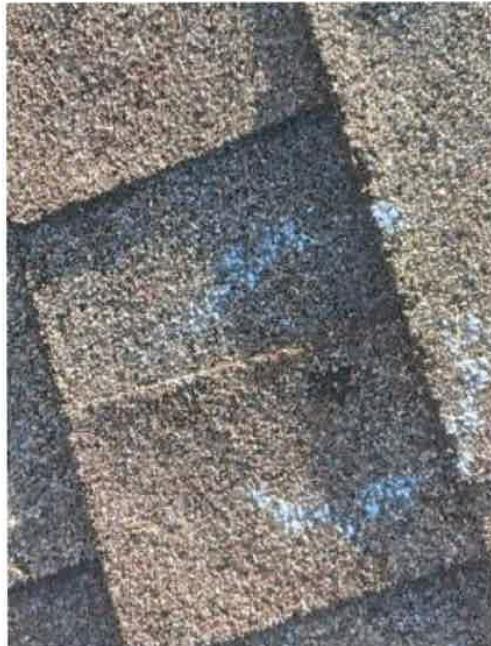
23 22-hail hit

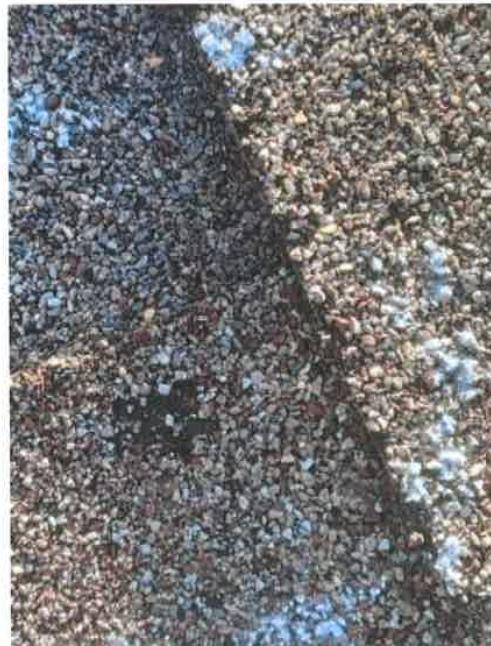
24 23-hail hit

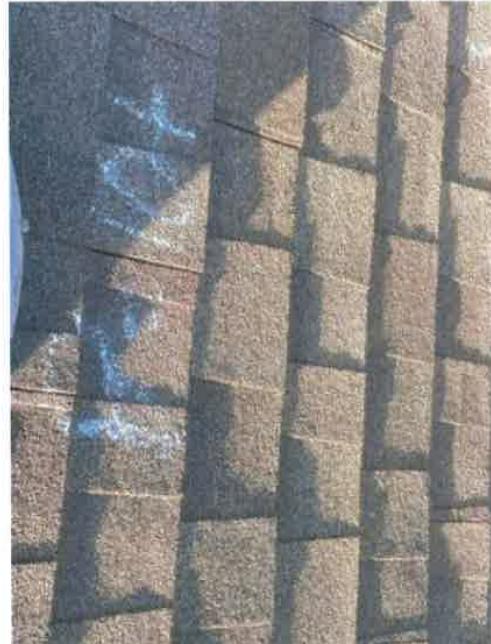
26 25-front

This is written by SF representative  
who believed there were 10+ hail hits.

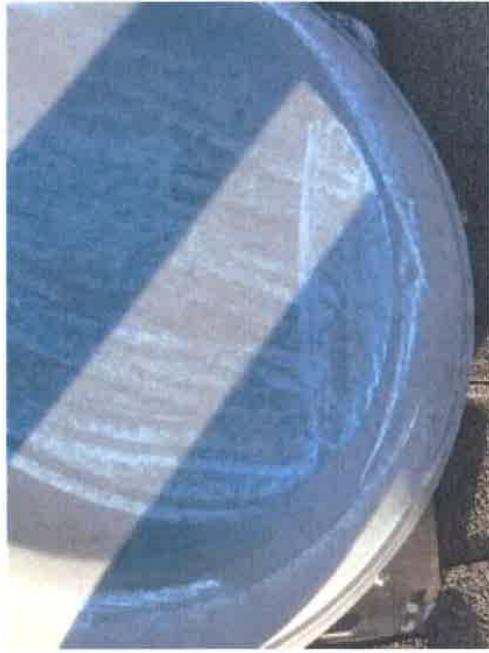
27 26-hail hits

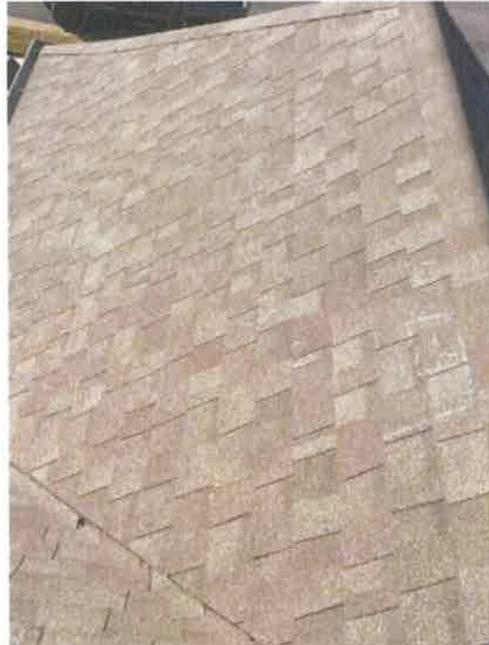
28 27-Left

White writing is from SF  
representative

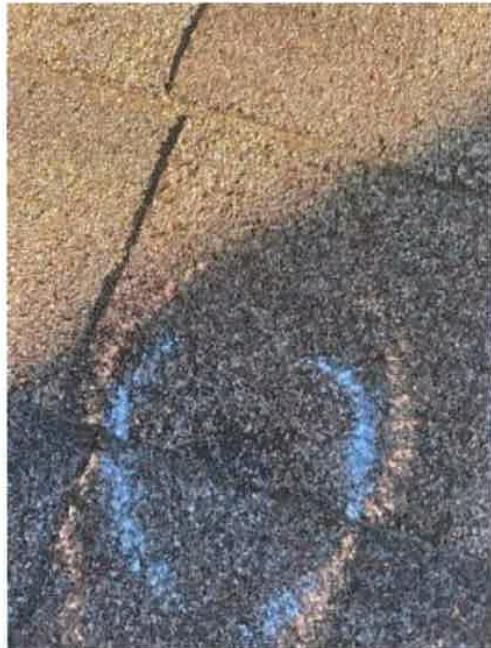
31 30-hail hit

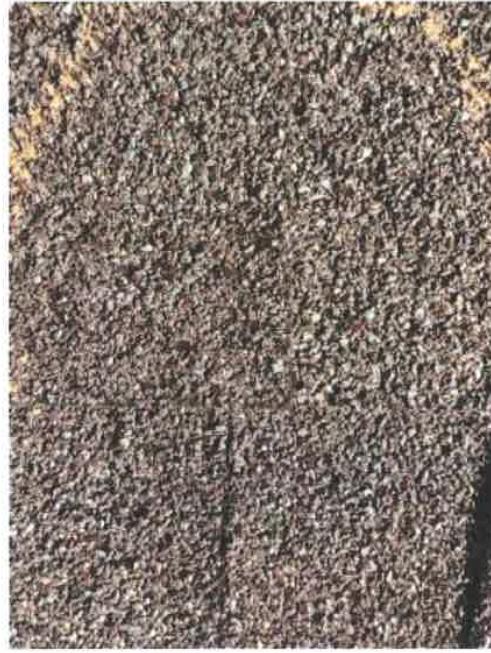
33 32-hail hit

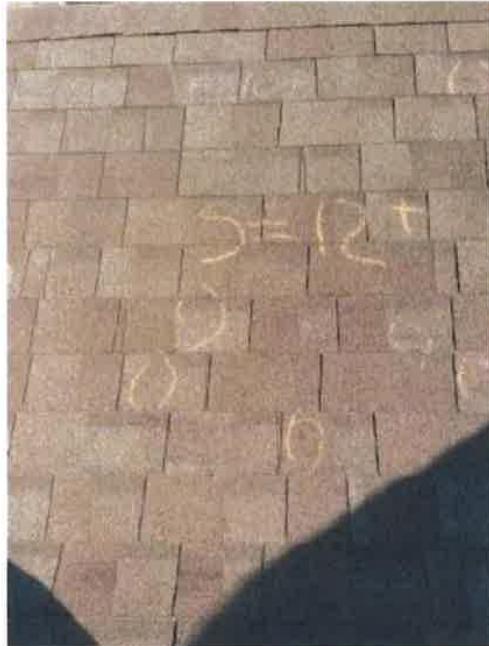
35 34-South

You can see white writing which was  
by SF representative stating 10+ hits  
and orange chalk by PA with 12+ hail  
hits.

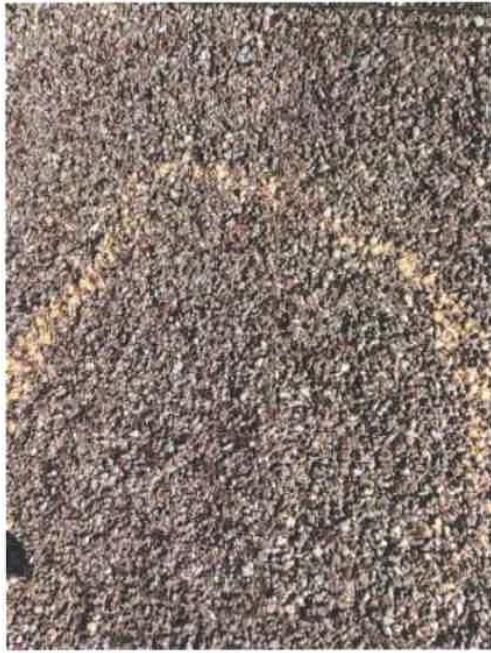
39 38-hail impacts  
Date Taken: 1/28/2022

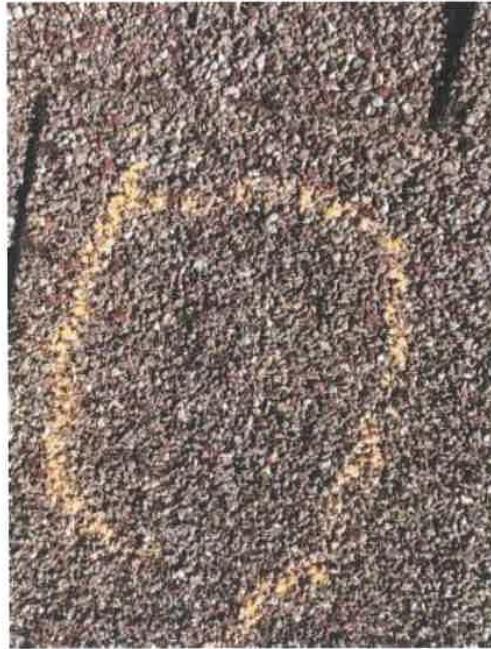
40 39-hail hits  
Date Taken: 1/28/2022

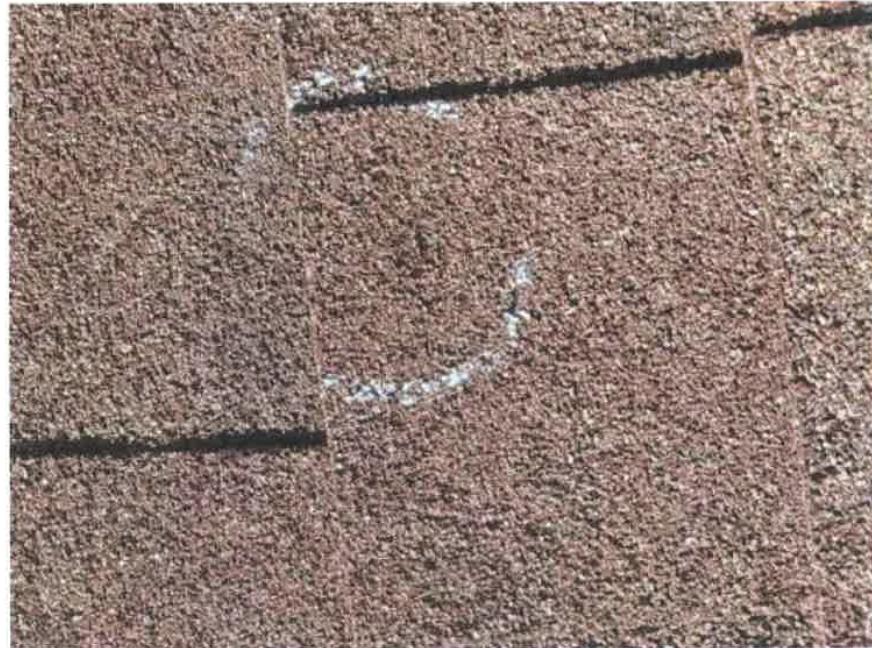
41 40-hail hits  
Date Taken: 1/28/2022

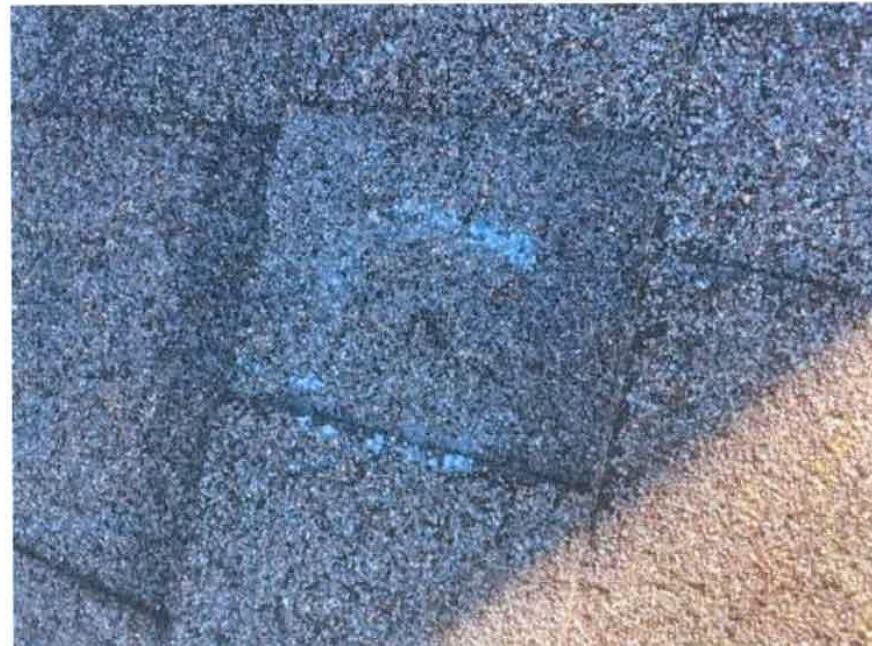
42 41-hail hits  
Date Taken: 1/28/2022

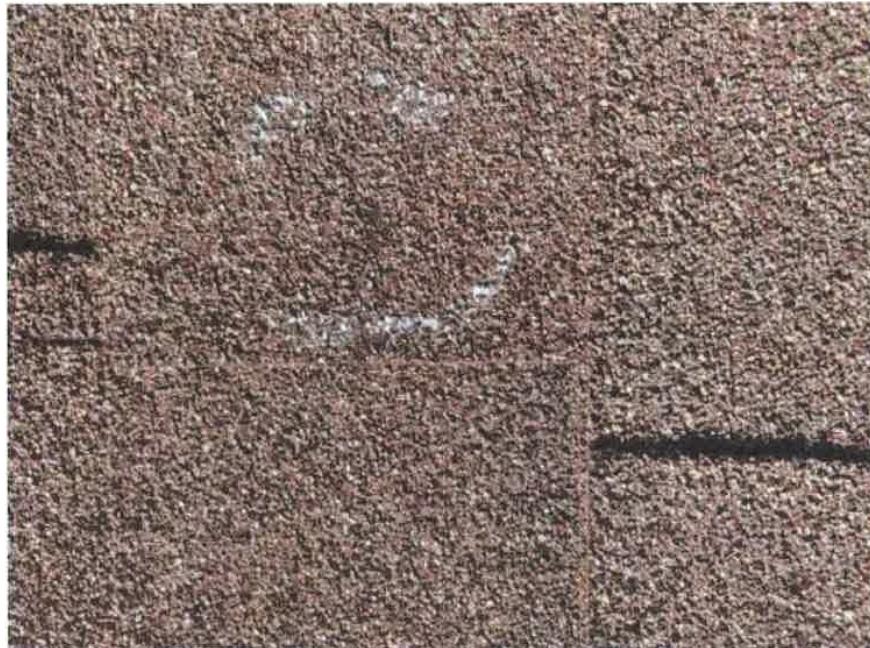
43 42-hail hits

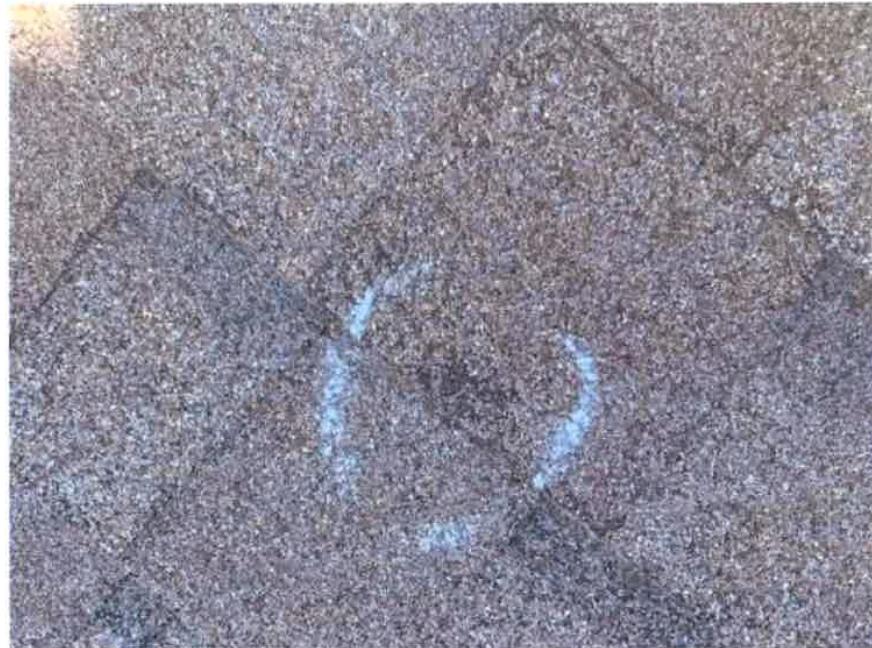
45 45-Hail impact  
Date Taken: 1/28/2022

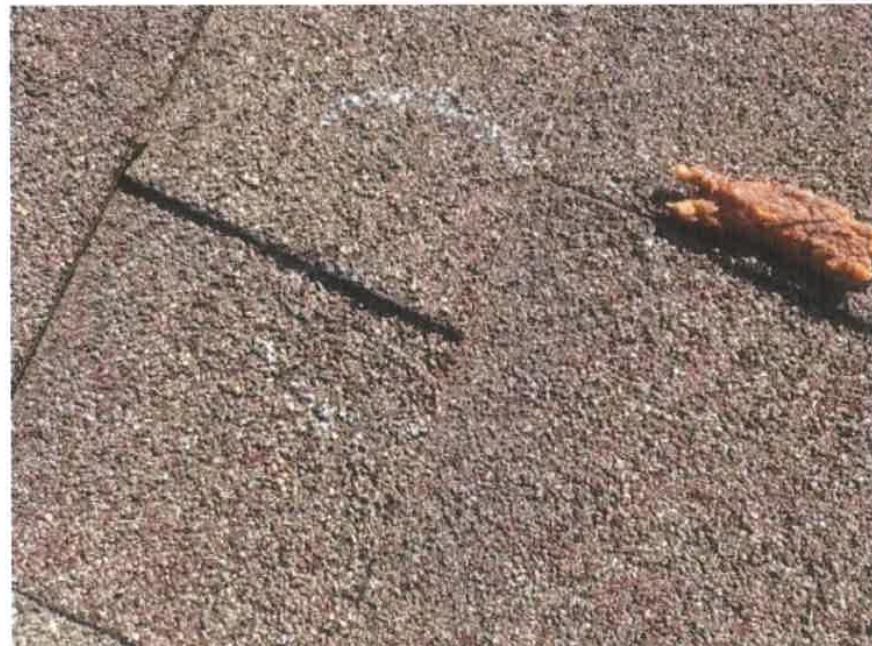
46 46-hail damage  
Date Taken: 1/28/2022

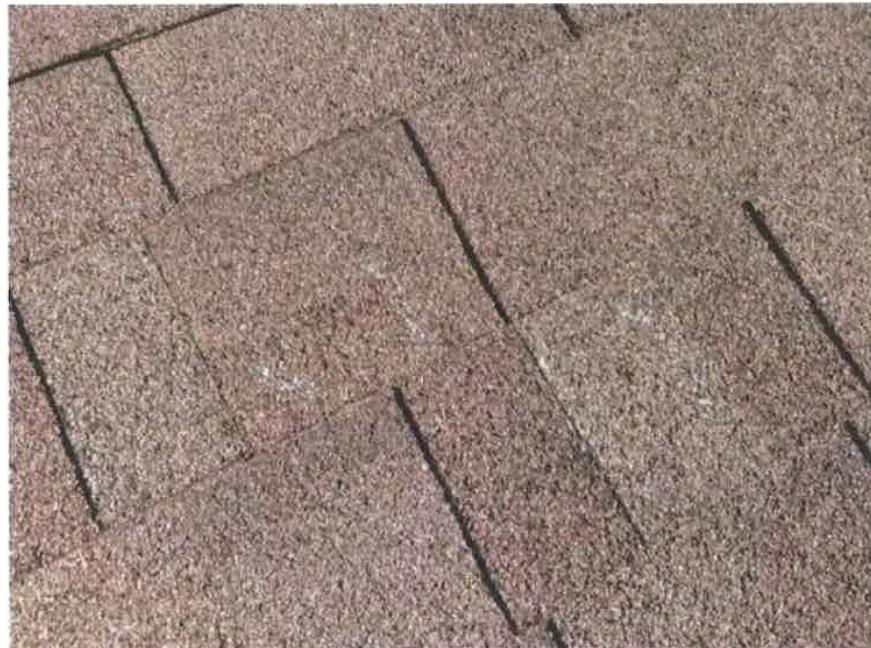
47 47-hail impacts  
Date Taken: 1/28/2022

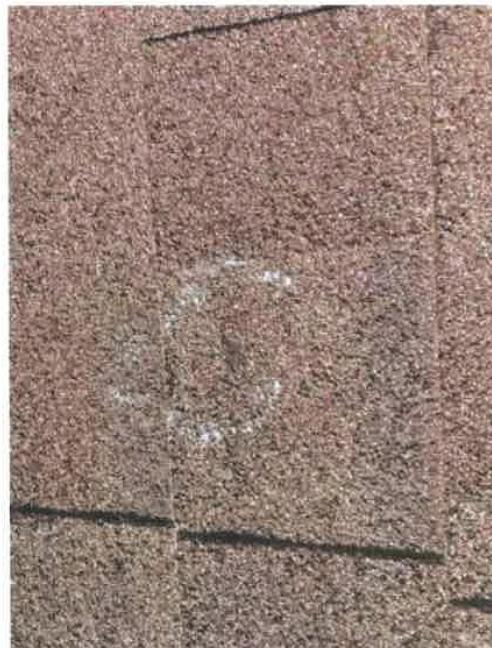
48 48-hail impacts  
Date Taken: 1/28/2022

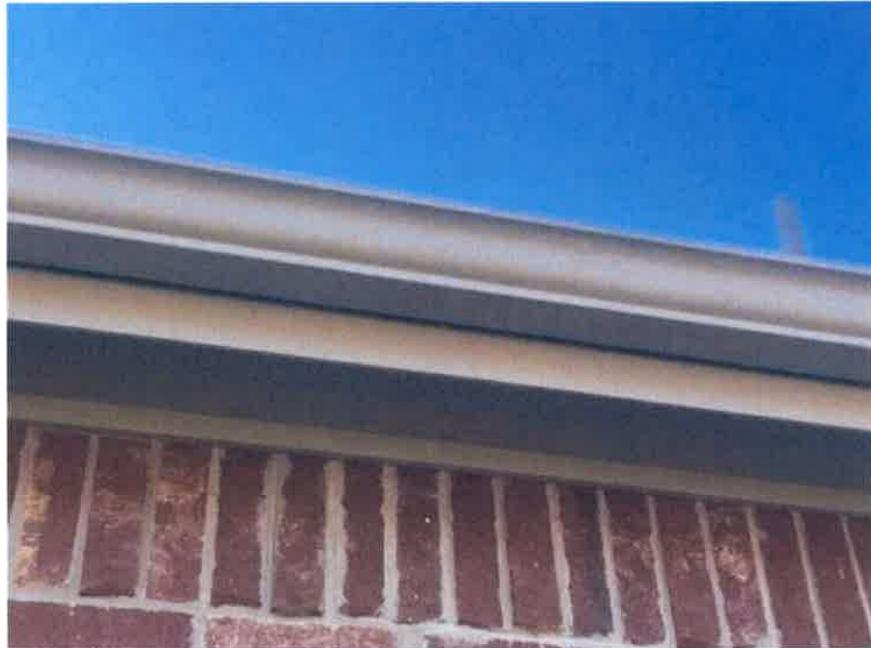
61 125-hail impact  
Date Taken: 1/28/2022

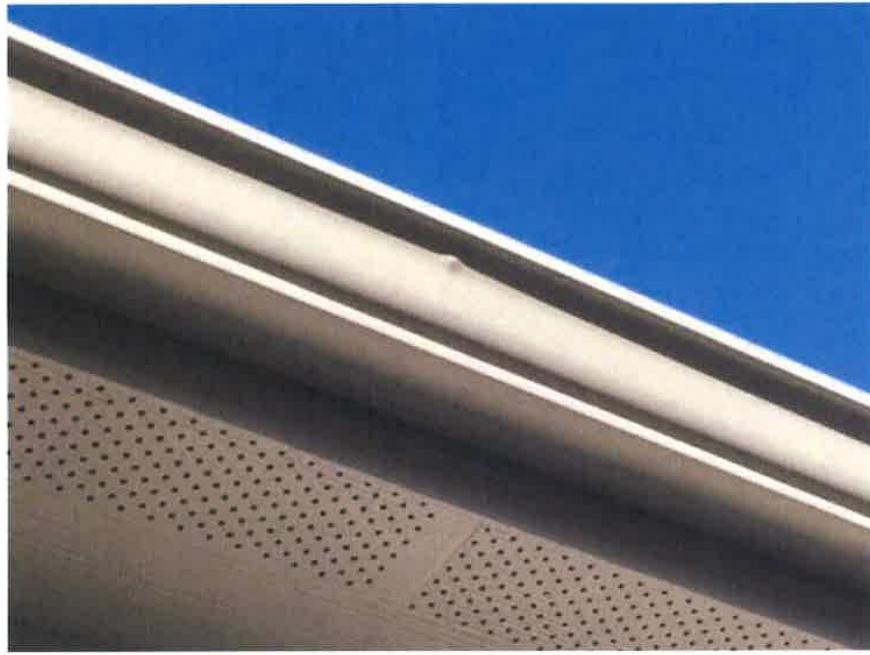
63 127-hail impacts  
Date Taken: 1/28/2022

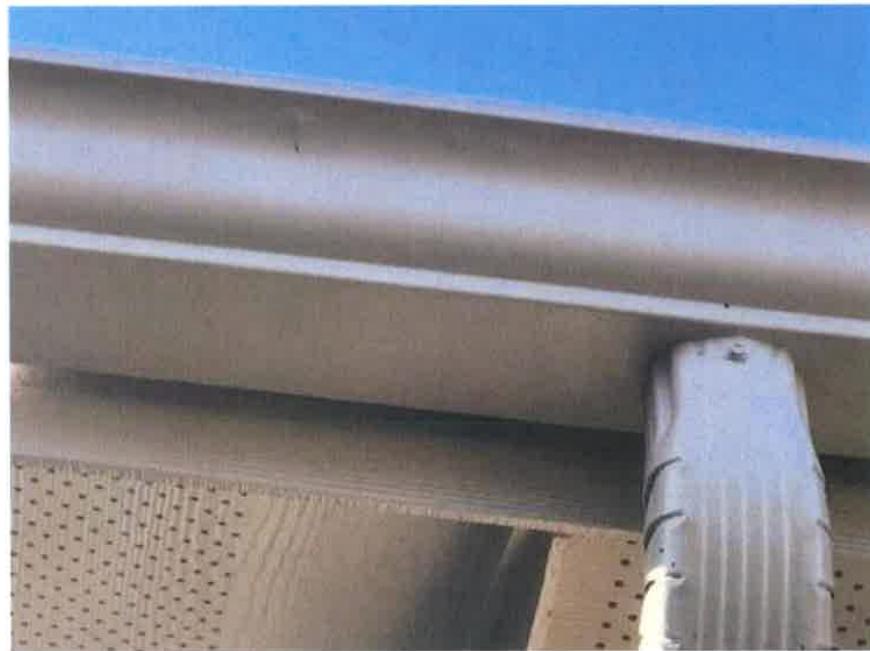
64 128-hail impacts  
Date Taken: 1/28/2022

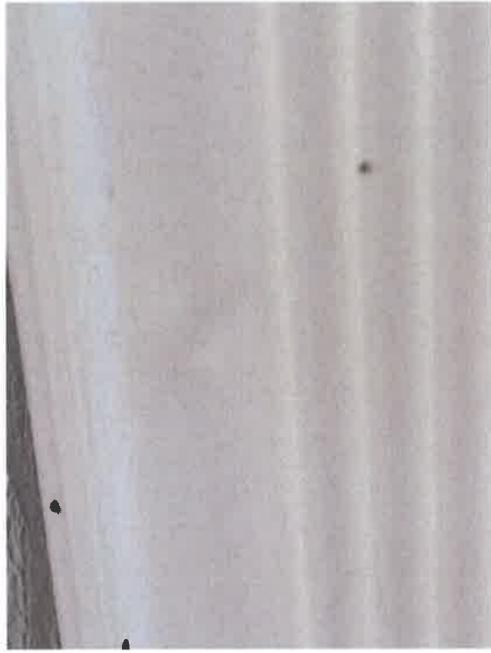
65 129-hail impact  
Date Taken: 1/28/2022

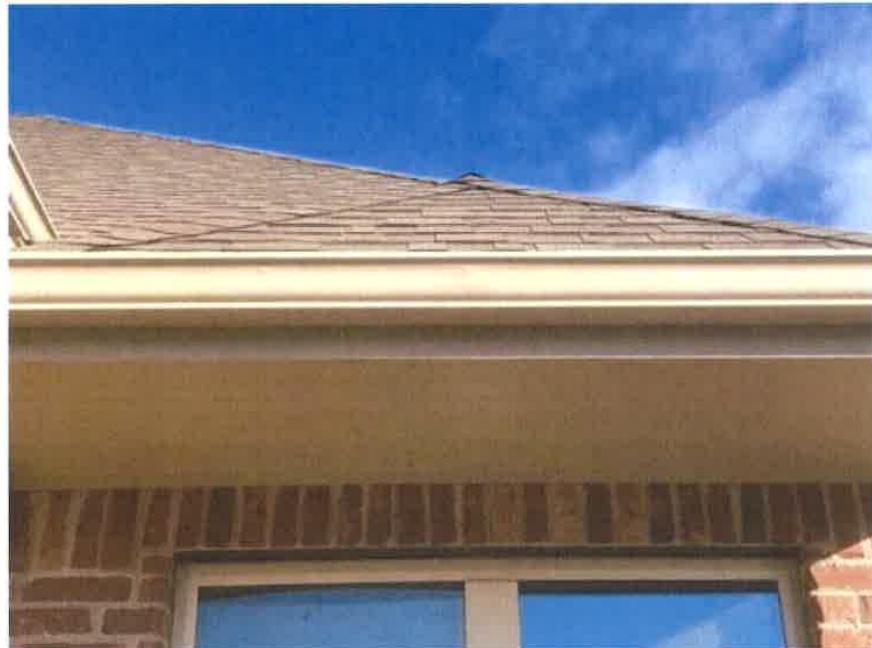
69 133-gutter  
Date Taken: 1/28/2022

Hail impact

7. R&R Gutter / downspout - aluminum - up to 5"	450.00 LF	7.34	152.92	725.74	4,181.66	(0.00)	4,181.66
17. Prime & paint gutter / downspout	450.00 LF	1.36	8.43	130.29	750.72	(0.00)	750.72

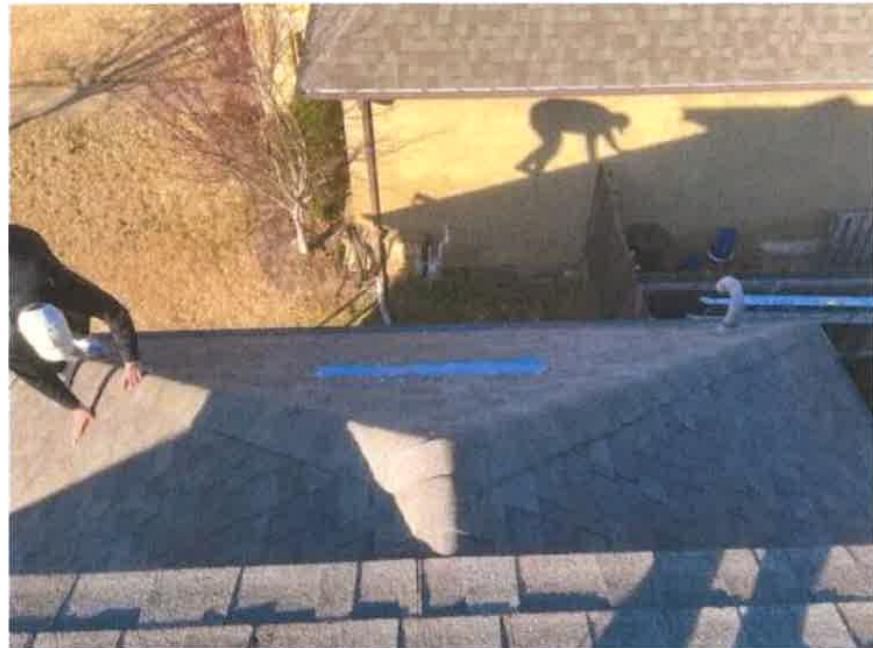
71 135-Tarped area  
Date Taken: 1/28/2022

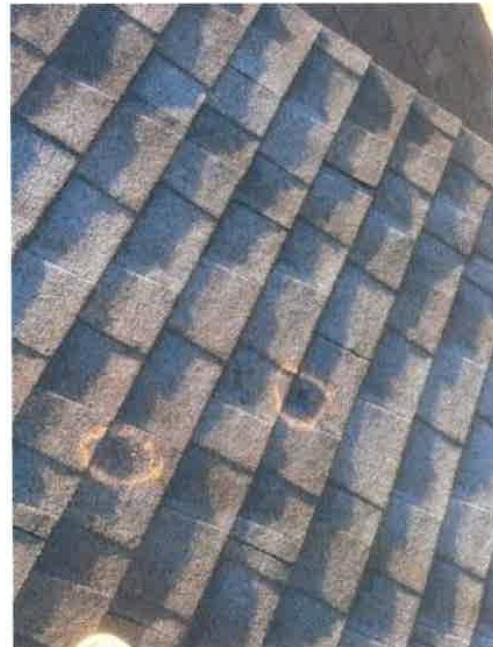
74 138-Hail Hit  
Date Taken: 1/28/2022

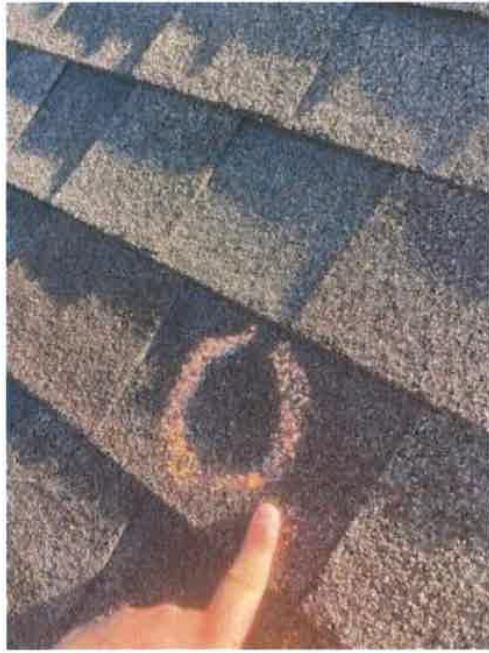
75 139-Hail hit  
Date Taken: 1/28/2022

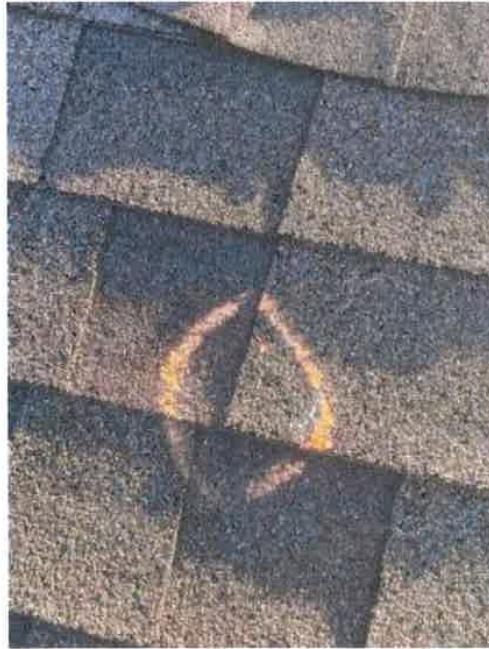
76 140-hail hit  
Date Taken: 1/28/2022

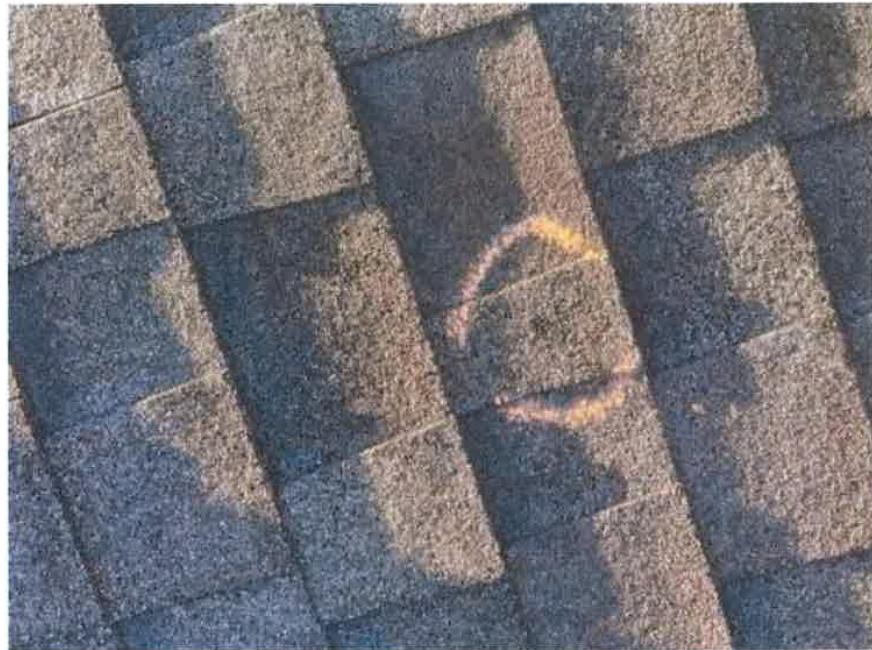
77 141-Hail hit  
Date Taken: 1/28/2022

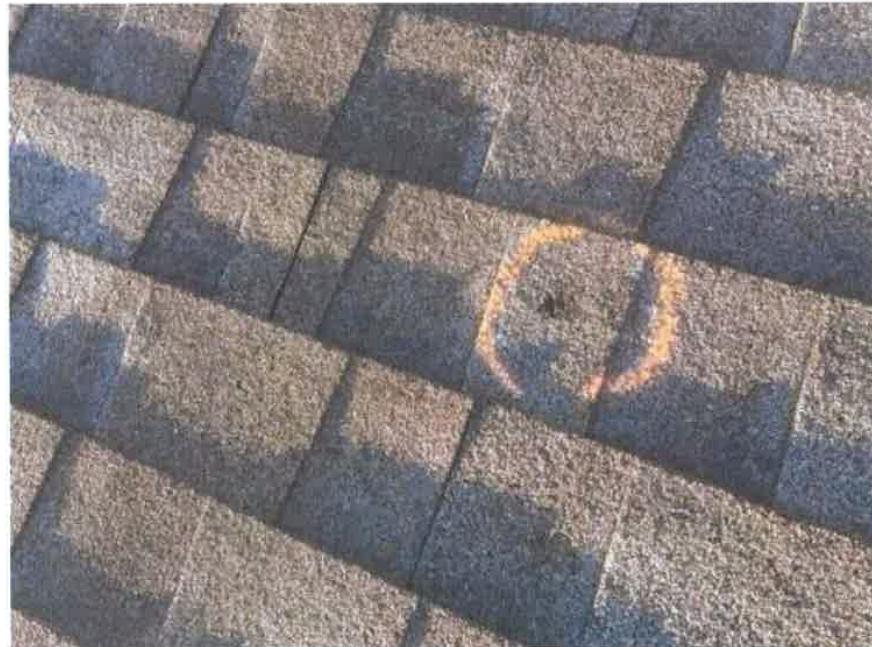
78 142-Hail Hit  
Date Taken: 1/28/2022

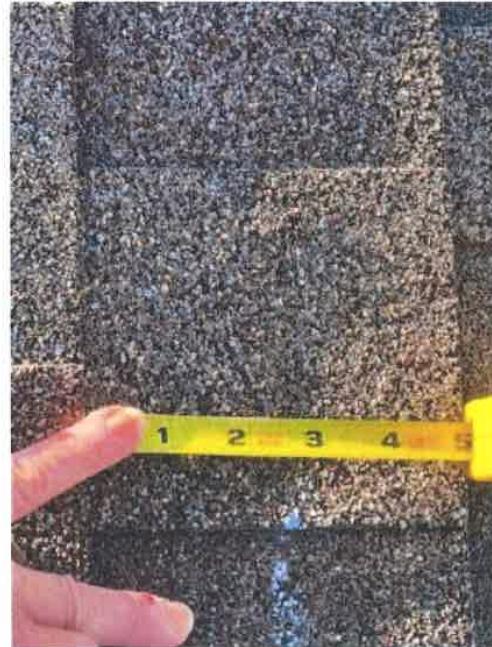
82 146-5 in exposure

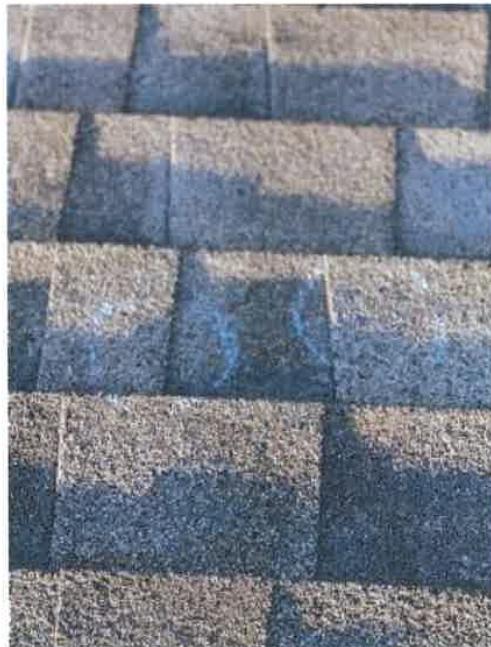
84 149-Hail hits

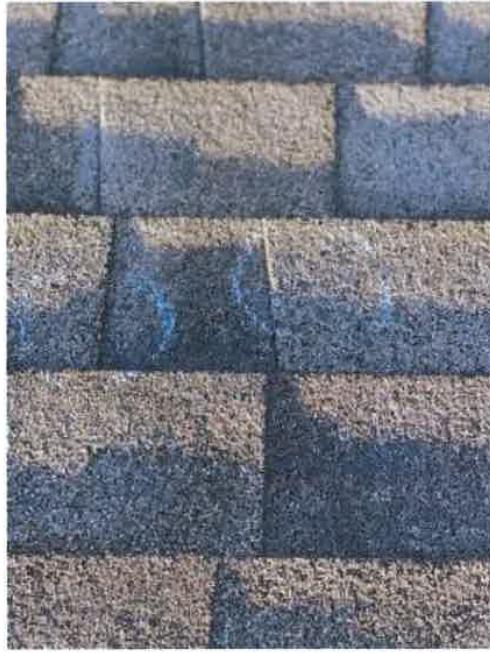
85 150-Hail hits

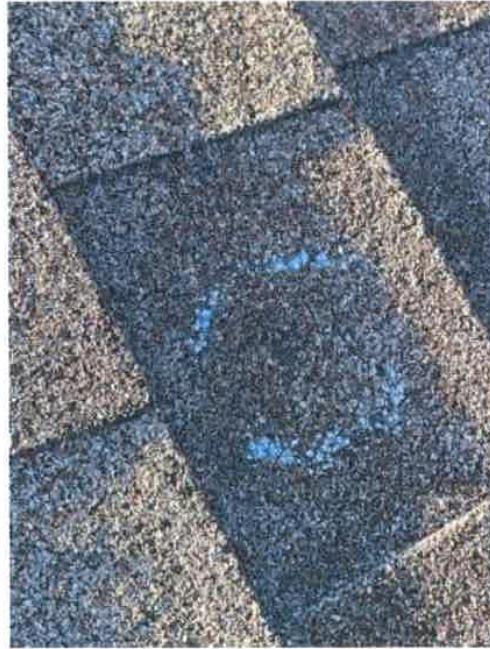
86 151-Hail Hits

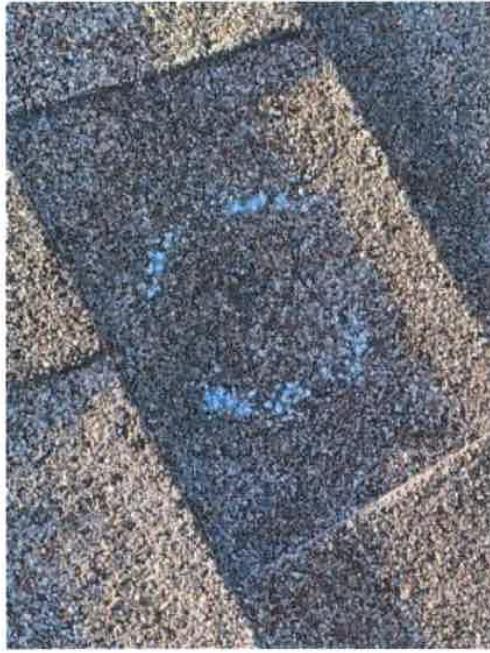
87 152-Hail hits  
Date Taken: 1/28/2022

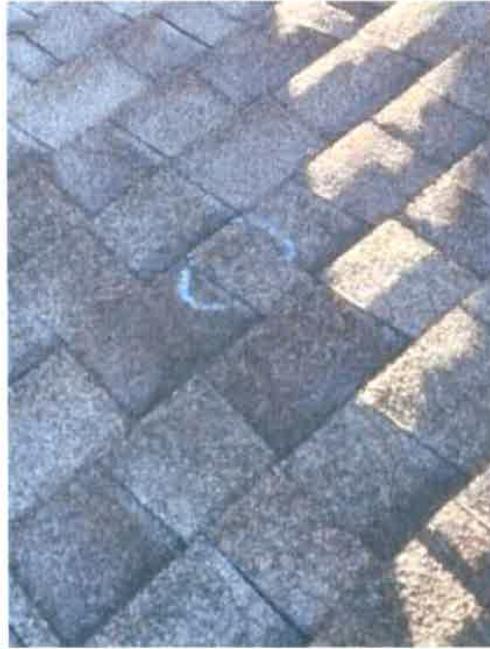
88 153-Hail Hits  
Date Taken: 1/28/2022

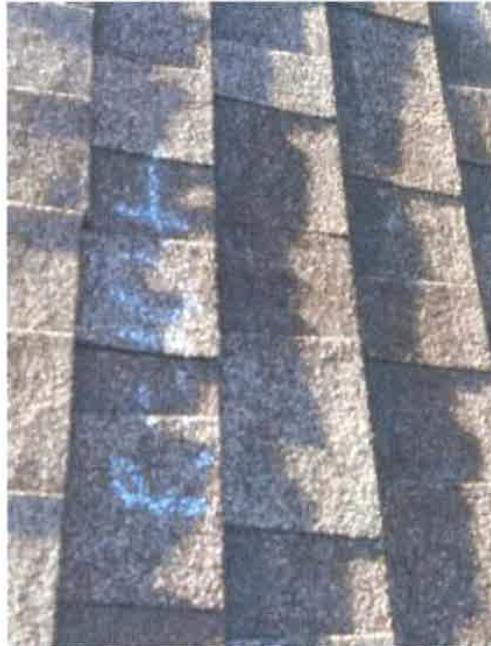
89 154-Hail Hits  
Date Taken: 1/28/2022

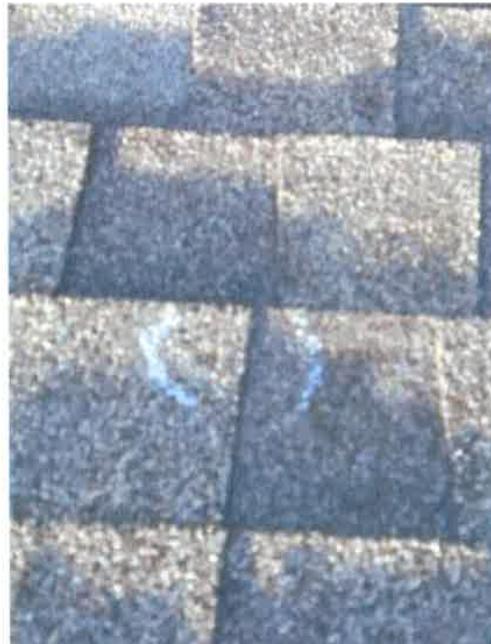
90 155-Hail Hits  
Date Taken: 1/28/2022

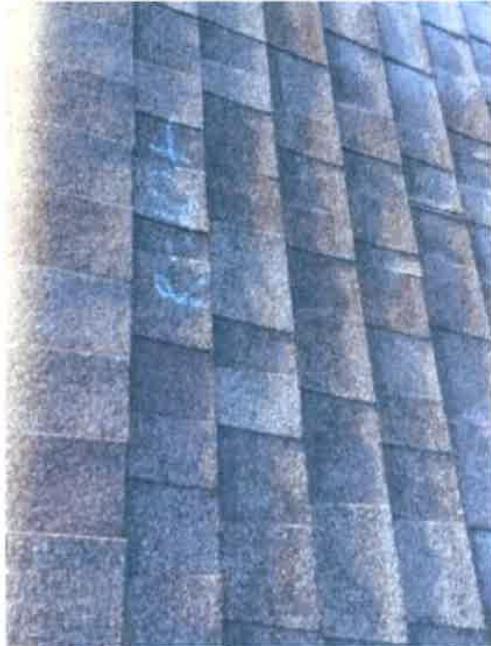
91 156-Hail markings by SF rep  
Date Taken: 1/28/2022
